Re: Notice of Violation  
Compliance Evaluation Inspection  
OHD987014594

**COMPLIANCE EVALUATION INSPECTION REPORT**

**SITE NAME:** Adelman's Truck Parts Corporation

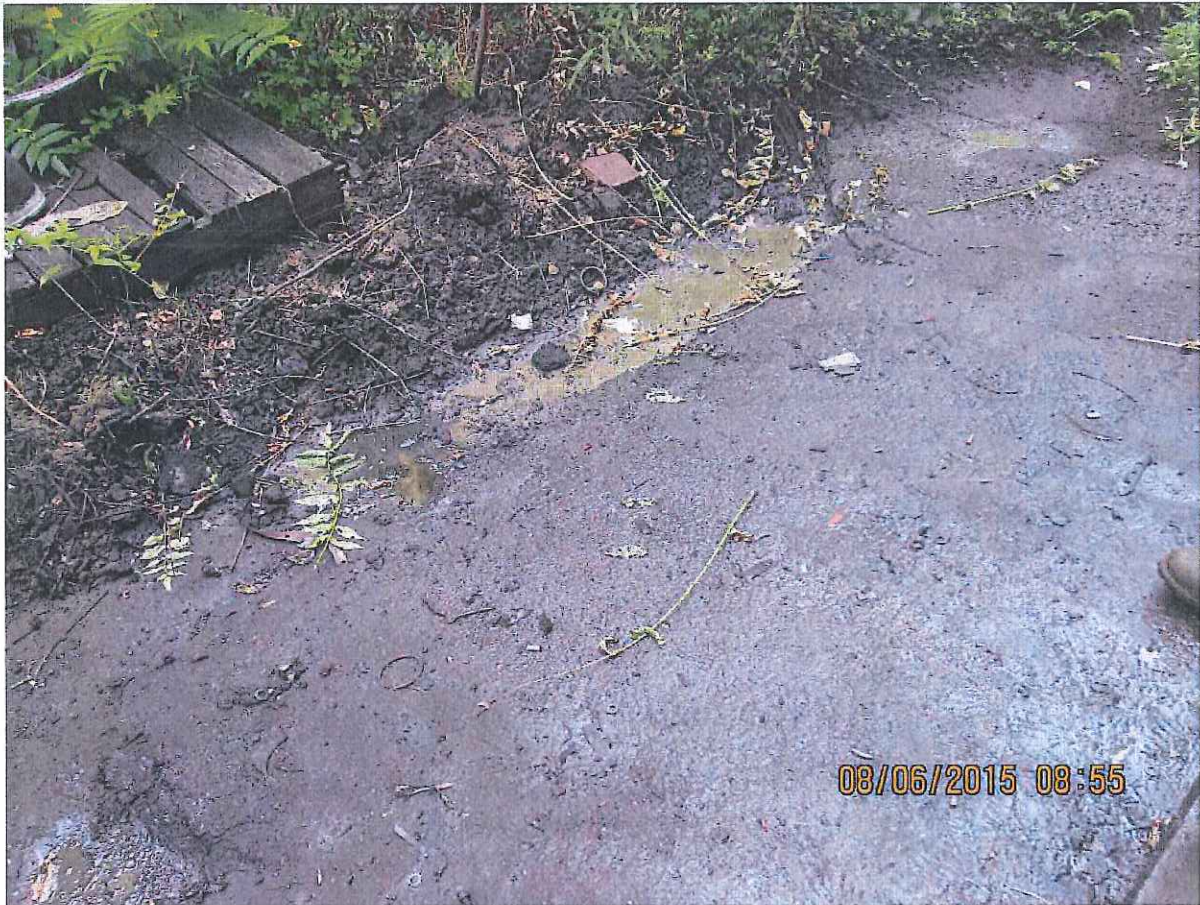
**Photo 1:**

- Used oil had drained outside an eastern exit of the Rebuild and Maintenance Shop and accumulated in an unlined ditch. Soil along the length of the ditch appeared to be stained with oil. No efforts to contain or clean the release were observed.
- In the Engine Department’s Building #3, oil-soaked absorbent material was observed on the ground around a used oil storage area. No efforts to remove the oil-soaked material were observed.
- Outside the south side of the Engine Department’s Building #4, a large oil stain was observed underneath a damaged steel dumpster. No efforts to contain or clean the release were observed.

Photo	Description	Time (CST)
1	Oil in the ditch outside the eastern edge of the Rebuild and Maintenance Building.	8:55 AM
2	Oil-stained soil in the ditch outside the eastern edge of the Rebuild and Maintenance Building.	8:55 AM
3	A drum accumulating parts washer sludge and waste xylene inside the Rebuild and Maintenance Building.	8:59 AM
4	A used oil collection and storage area inside the Engine Department (Building #3).	9:10 AM
5	A used oil collection and storage area inside the Engine Department (Building #4).	9:16 AM
6	A used oil storage tank inside Building #4.	9:16 AM
7	A collection grate along the southern edge of Building #4 which ties into the stormwater management system.	9:17 AM
8	A dumpster that appeared to have spilled used oil near the area outside Building #4.	9:25 AM
9	A tote of used oil that appeared to have spilled at the covered outdoor disassembly area.	9:29 AM
10	Stormwater and used oil had collected in the grates which run along the concrete pad at the outdoor disassembly area.	9:31 AM

On September 5, 2015, ATP provided photographs that display the cleanup of certain areas outlined above. These areas include the ditch outside the Rebuild and Maintenance Shop, the containment grates at the outdoor disassembly pad, and the stains observed on the ground at the outdoor disassembly yard. However, the photographs did not display any corrective actions taken to clean up the oil-soaked absorbent observed in the Engine Department's Building #3, the oil-stained soil near the steel dumpster outside the Engine Department's Building #4, or the oil-stained soil adjacent to a used oil tote at the outdoor disassembly pad. ATP, therefore, failed to properly respond to releases of used oil and remains in violation of the above requirements.

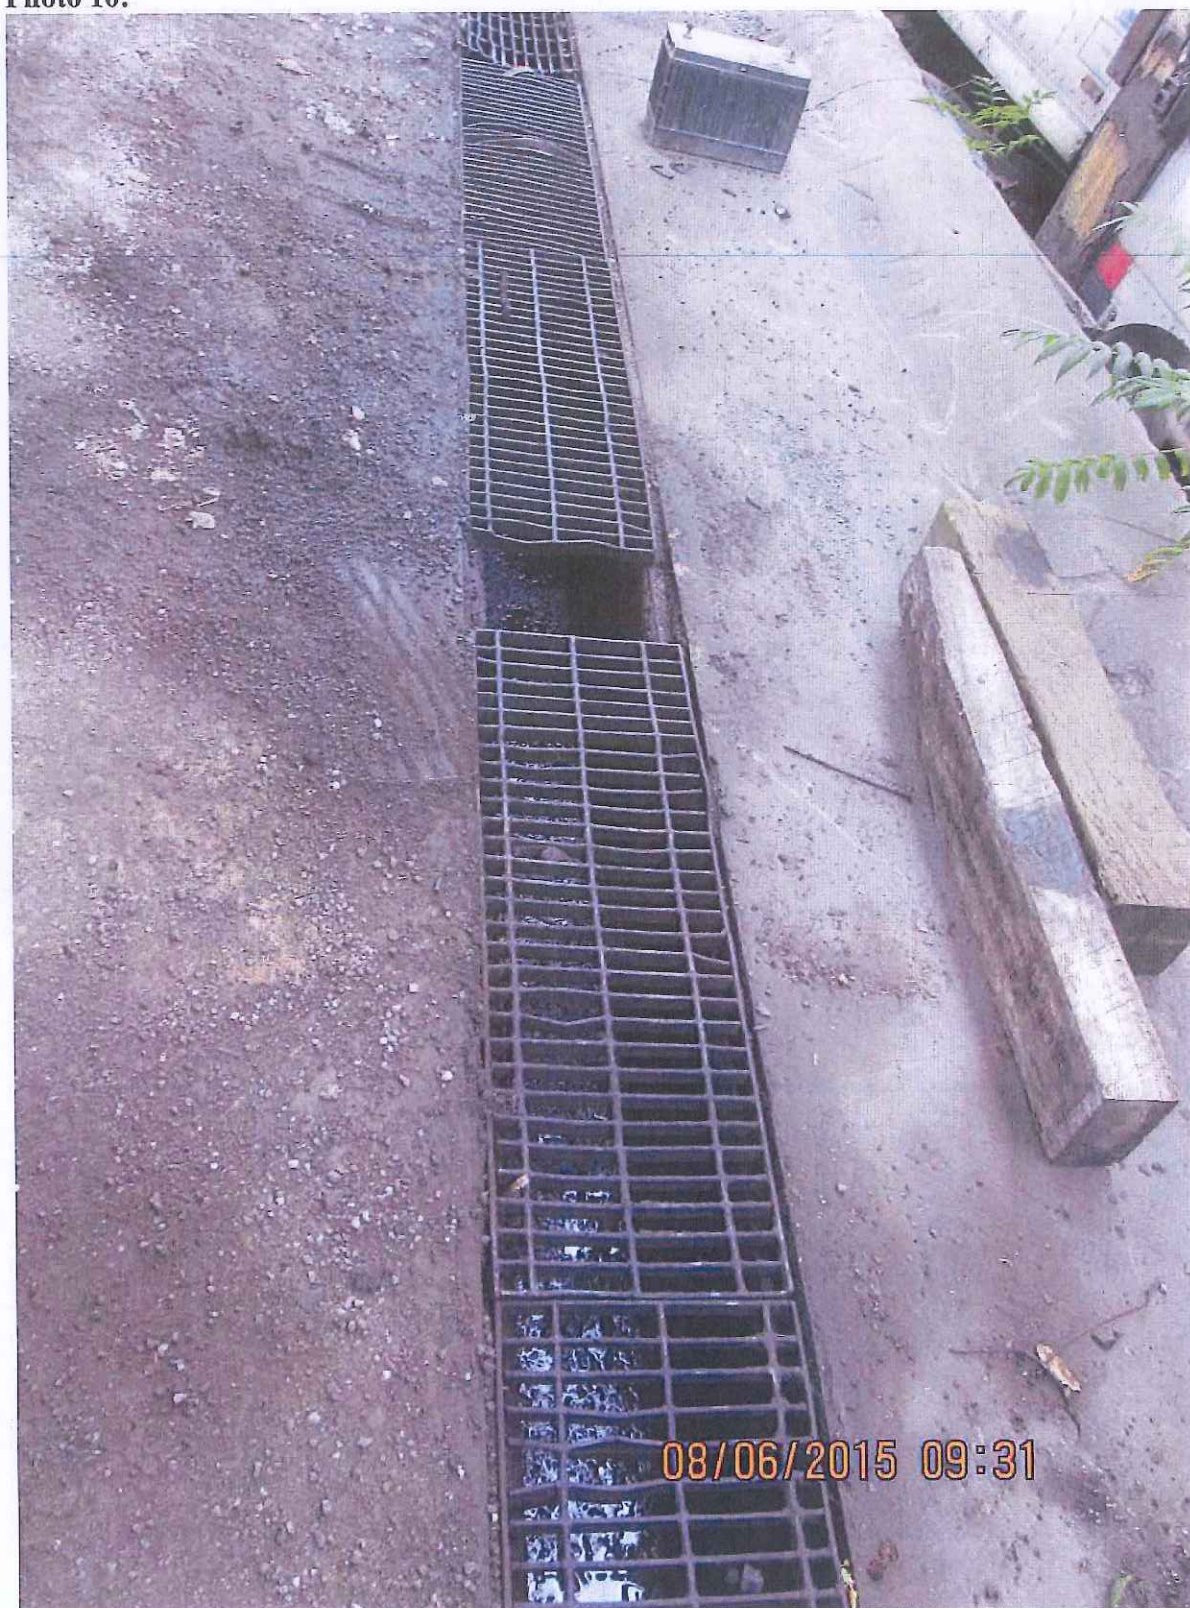
**Photo 10:**

- At the outdoor disassembly pad, oil-stained soil was observed near a plastic tote that had been accumulating used oil. Used oil had also accumulated in the containment grates surrounding the disassembly pad. No efforts to contain or clean the releases were observed.
- At the outdoor disassembly yard, several large stains of oil were observed on the soil and gravel in the area. No efforts to contain or clean the release were observed.

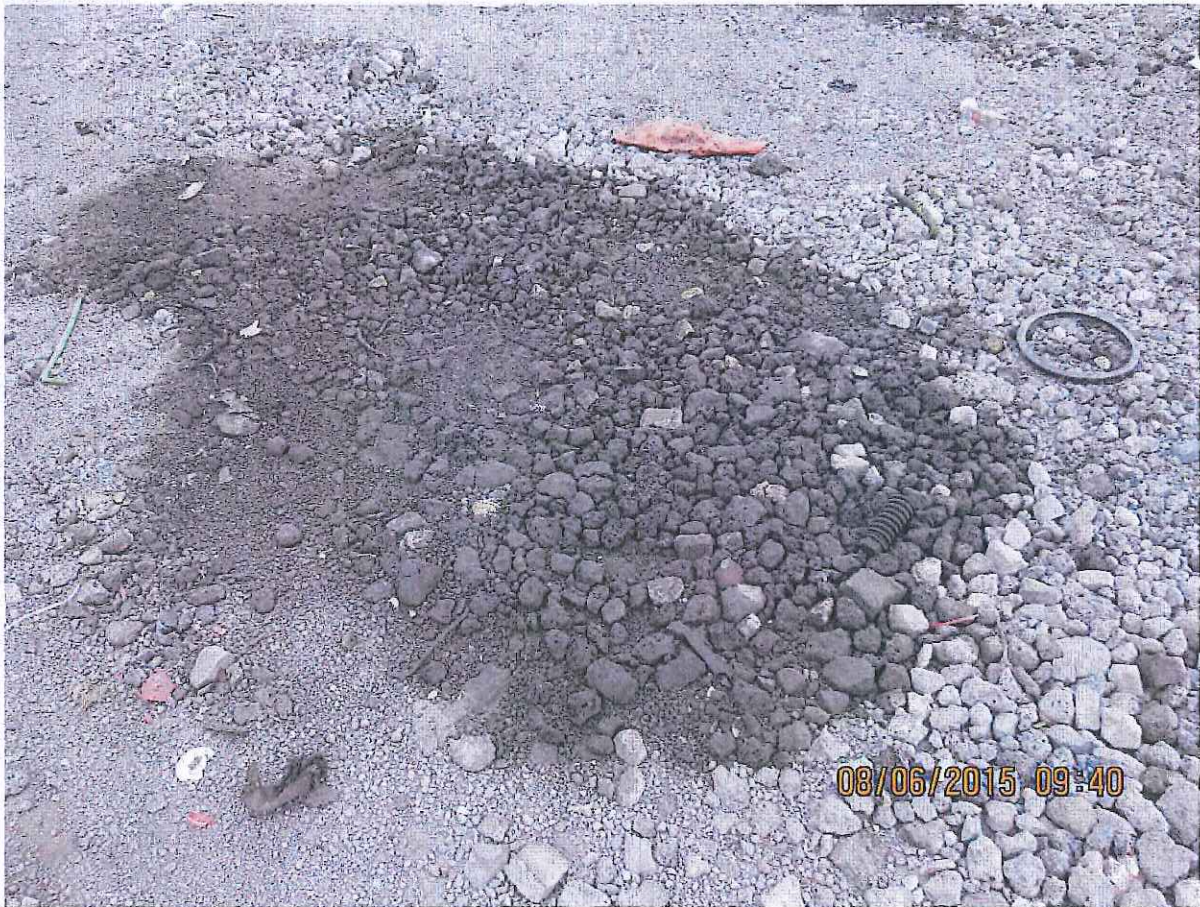
**Photo 11:**

11	A large oil stain on the soil at the large outdoor shearing area.	9:40 AM
12	Another large oil stain on the soil at the large outdoor shearing area.	9:41 AM
13	Used oil accumulating in the drainage pits (tanks) inside the Transmission and Axle Building (Building #5).	9:50 AM
14	Dozens of automotive batteries on wooden pallets in Building #5.	9:52 AM
15	A battery in Building #5 that appeared to be leaking acid.	9:53 AM
16	Several drums of oily parts washer water in Building #5.	9:57 AM
17	A full drum of parts washer sludge in Building #5.	9:57 AM
18	A full drum labeled as non-hazardous waste. It was unclear what waste was being stored in this drum.	9:57 AM
19	Many boxes of universal waste lamps in the Engine Department.	10:44 AM
20	A large open box accumulating universal waste lamps in the Engine Department.	10:44 AM
